STRUCTURAL HEALTH MONIROING OF VISAKHAPATNAM PORT TRUST BRIDGE

OVERVIEW

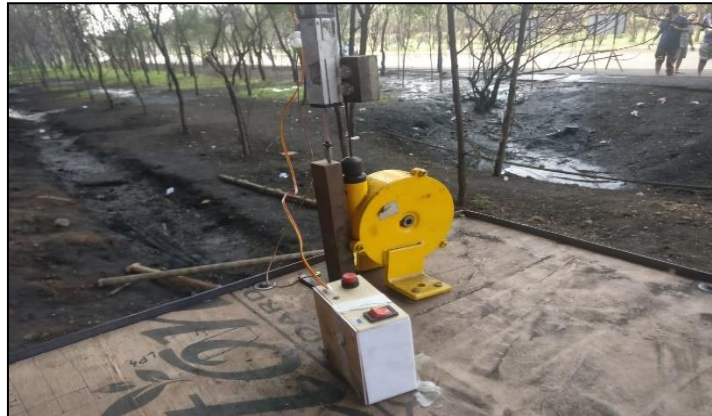
Fig 2: - Linear Potentiometer to find deflection.

- **Deflection Measurement:** -The mid Span Deflections were taken by installing the LVDT's at the mid of Girders. Draw wire type arrangement were used to connect the displacement sensors to the soffit of the girder.

- 4) The maximum deflection of 6 mm has been recorded at mid-span of the girder at the centre of span 69-70 where Linear Potentiometers were placed
- 5) The natural frequencies of the girders are in the range of 4.411 Hz to 4.612 Hz. There is very minor variation in natural frequencies which indicate that the flexural stiffness of girders is almost similar.

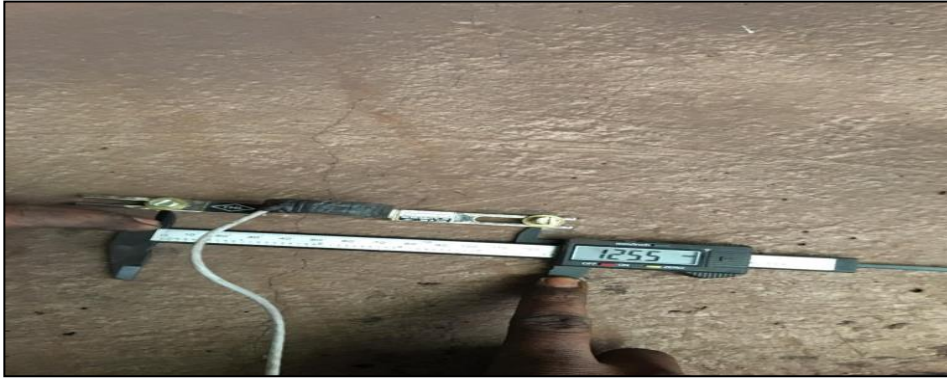
Fig 4 :- Omega Sensor and Vernier Calliper to measure crack width.

- **Crack Width measurement:** - In this test, the increase in width the existing cracks were measured. An omega type displacement transducer (crack width sensor) was mounted across the crack. It is a strain gauge-based transducers which can measure minute displacements.

- 6) The maximum inclination has been recorded as 0.6 degrees for girder G4 of span 70-71.
- 7) These openings are of considerable magnitude and are in the range of 0.6 mm to 0.9 mm. This indicates that these are active structural cracks and required to be repaired on priority.

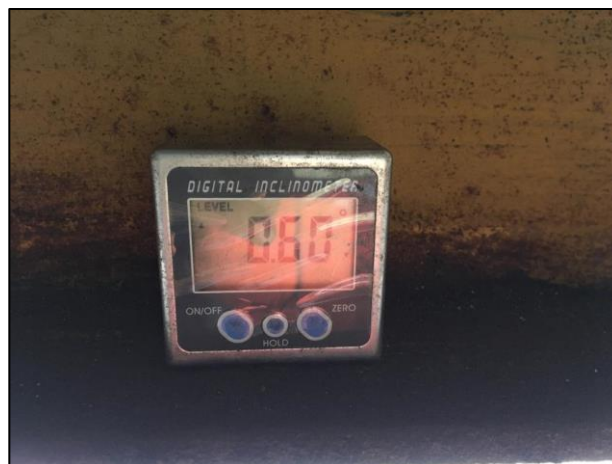
Fig 5: Digital Tiltmeter

- **Measurement of Girder Inclination:** - A digital magnetic inclinometer with an accuracy of 0.05 degrees was used to study the inclination of girders before and after the Static Load Test. Inclinometer were mounted on a metal surface which was bonded to the girder with a proper adhesive and sealing compound.

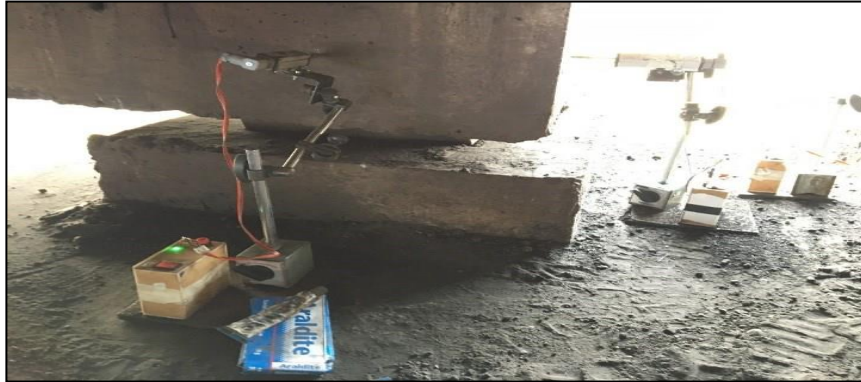
Fig 6: Placing of Linear Potentiometer

During inspection it was found that all girders are displaced longitudinally from their original position creating gaps in expansion joints. Some gaps are so huge that it can be easily noticed from top as the gaps are opened up with filler material.

- 1) It was found by visual inspection that the condition of expansion joints is not good. There huge gaps between expansion joints and the joints have got opened despite the filler material.

- 2) This has initiated the hammering action of vehicles which are further worsening the condition of joints. The impact of vehicles while passing the gap can easily be felt at bridge site. These gaps are created due to random longitudinal movements of girders.

- 3) The maximum longitudinal and transverse displacement measured is 0.58 mm and 0.44 mm respectively. This indicates that due to longitudinal braking forces of test vehicles, the girders got displaced slightly even after removal of loads.

- 8) Expansion joints got damaged and improper which need to be repaired as and where required.
