Jawaharlal Nehru Port Trust (JNPT), Navi Mumbai.

JNPT decided to take up the rehabilitation work of the Karal Railway Over Bridge (ROB). It got functional in 1991. There are 36 spans of varying lengths having 37 expansion joints in this bridge and the length is 700m. During the heavy rains in July, 2005 the wearing coat and expansion joints were severely damaged. These damaged coats and joints were subsequently repaired and re-laid. But the bridge was still not working satisfactorily. The vibrations of bridge during the vehicle movement were becoming more and more noticeable. The major observations during the site visit are as follows...

Instrumentation of Bridge for checking the Efficacy of the proposed rehabilitation measures.

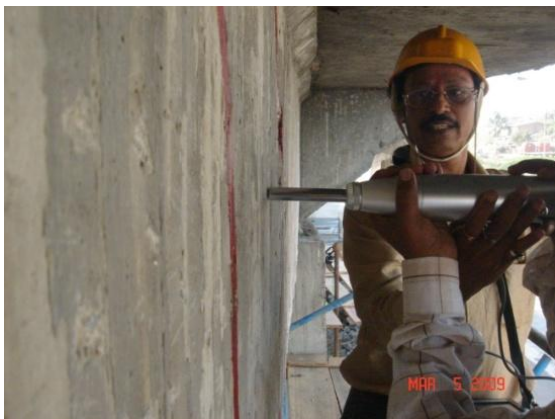
Two types of NDT tests on the superstructure were carried out. It included Rebound Hammer Test and ultrasonic pulse velocity tests (Direct) on the girders.

1. The NDT test results i.e the Rebound hammer test and the ultrasonic pulse velocity test concluded that the concrete is in sound condition.
2. Central deflections obtained under standard loads indicate significant improvement in the flexural stiffness of the RCC girder beams after rehabilitation and effectiveness of the pre-stressed steel truss straitening system. The average reduction in central deflection for loading condition inducing maximum deflection for each of the span is presented in the Table 21.

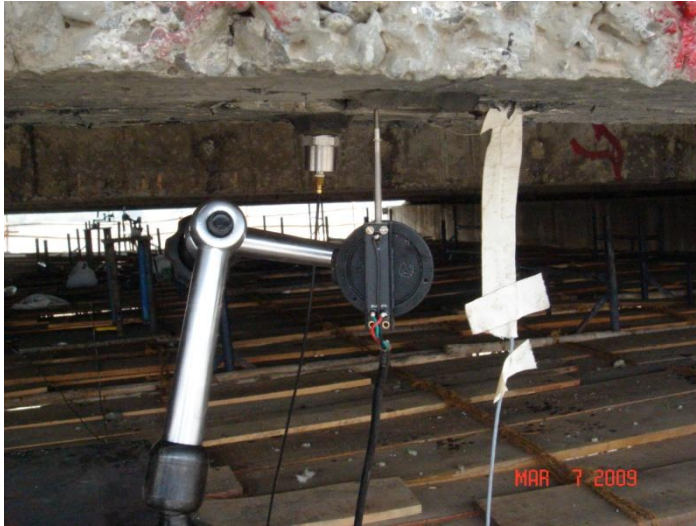
- Deflection measurements at the centre of the superstructures, before and after strengthening, by using linear potentiometer of “Sakae Japan” make, which were installed at the center of all three spans at 4 girder positions(1,3,5 and 7). Readings were taken by using standard loaded vehicles positioned to induce maximum deflection.

Span 1	Span 2	Span 3
Before strengthening	5.38 mm	5.18 mm	5.08 mm
After strengthening	3.93 mm	3.65 mm	3.95 mm
Reduction in defection	1.46 mm (27.1%)	1.53 mm (29.5%)	1.13 mm (22.2%)

Reduction in deflection of all the three spans indicates that the flexural strengthening system (FRP laminate and Pre-stressed steel truss system) is effective in sharing the

vehicular loads. An average of 26% reduction in the deflection of bridge superstructure under standard loads has been observed.

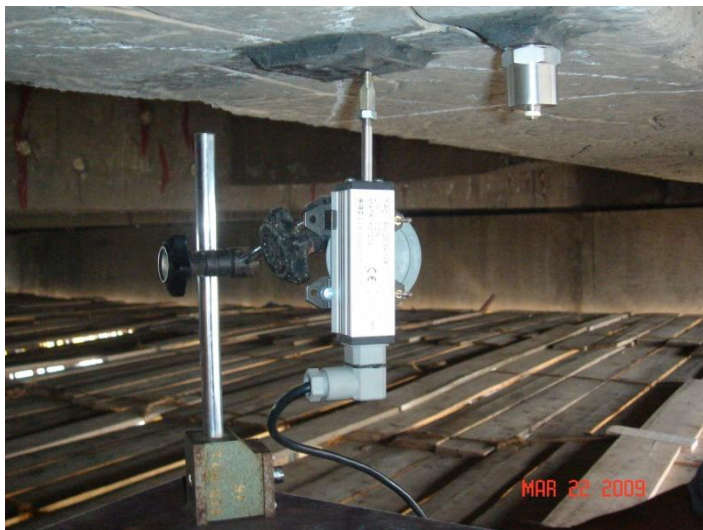
- To measure the change in frequency of vibration, before and after strengthening, of the girder piezoelectric accelerometers of B & K Denmark Make were mounted at the centre of the four girders on the bottom face in the mid span positions. Measurements were done with the help of standard loaded vehicle moving at constant velocity of 25 kmph.

Span 1	Span 2	Span 3
Before strengthening	21.38 mm/s ²	35.91 mm/s ²	85.92 mm/s ²
After strengthening	11.43 mm/s ²	15.93 mm/s ²	42.06 mm/s ²
Reduction in Acceleration	9.95 mm/s ² 46.5 (%)	19.98 mm/s ² 55.6 (%)	43.86 mm/s ² 51.0 (%)

Span 1	Span 2	Span 3
Before strengthening	5.301 Hz	5.344 Hz	5.520 Hz
After strengthening	5.737 Hz	5.964 Hz	5.833 Hz
Increase in Fundamental Frequency	0.436 Hz 8.2 (%)	0.620 Hz 11.6 (%)	0.313 Hz 5.7 (%)

5. Reduction in the vibration of the superstructure was envisaged due to rehabilitation of RCC girder beams and strengthening with steel truss system. Vibration measured at the mid-span of girders has been presented in the Tables 24 and 25.

An average reduction of 8.5% in fundamental frequency of vibration is achieved. In addition to this, the amplitude of acceleration has been reduced by 50%. The increase in fundamental frequency of vibration and reduction in amplitude of acceleration indicate that the significant improvement in the overall stiffness of the structure.
