CASE STUDY OF MITHI RIVER

Project Name: - Deflection test, Strain Test, Video Recording and submission of report for Bridge over Mithi River

Client: - Larsen & Toubro

Area: - Mumbai International Airport (Andheri E)

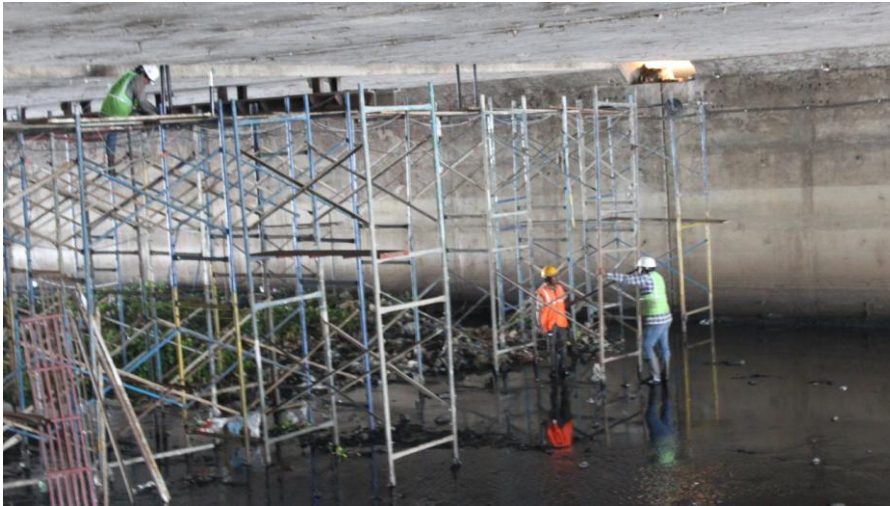
Fig .1

- Initially induction & assembly of scaffolding materials was provided for access to site to drill holes and to investigate

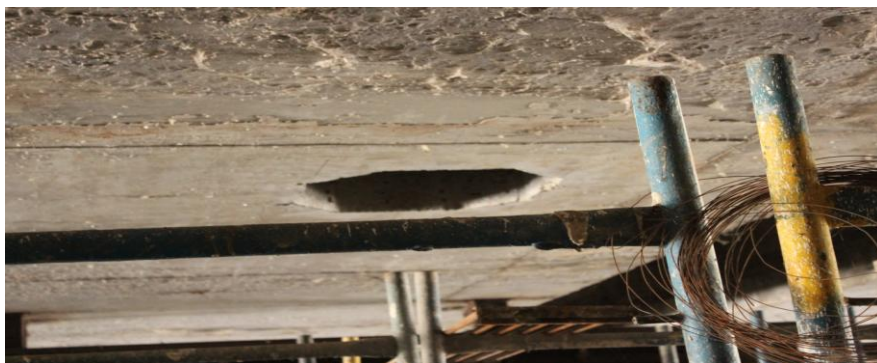
Fig . 2

- Octagonal holes were drilled according to drawing provided for detail investigation and crack mapping of the box girders

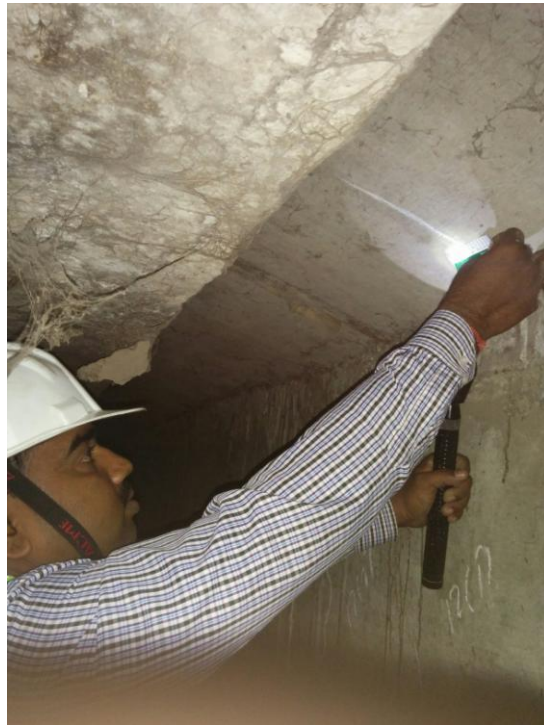
- Crack mapping was performed to measure width and depth of the cracks using feeler gauge and Crack width measurement card.

Fig 3.1 – Crack width Measurement card

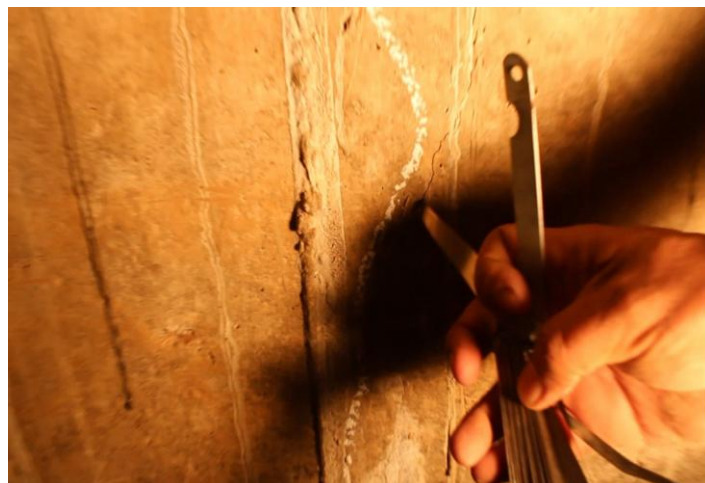
Fig 3.2 – Feeler Gauge

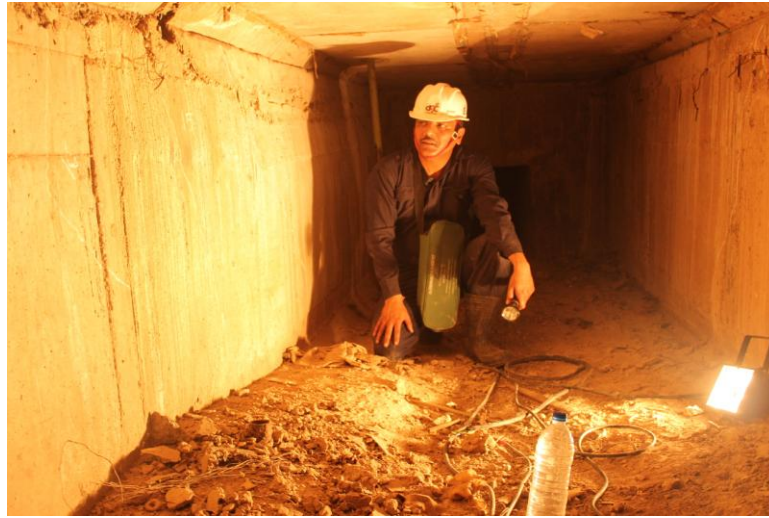
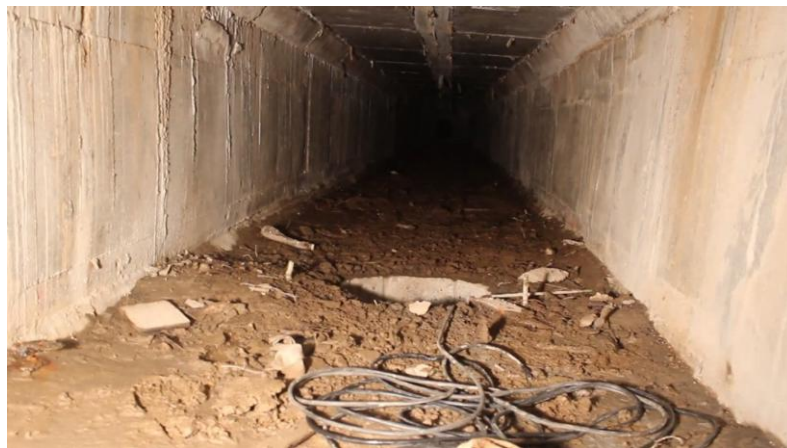
- Lots of cracks were observed inside the box girder and a detailed investigation was carried out.

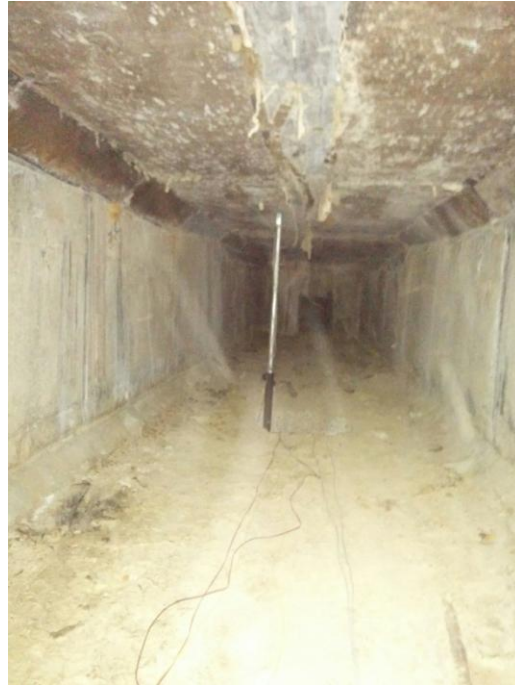
- Linear potentiometers and strain gauges were mounted at various locations as provided in the drawing to carry out the deflection and strain test.

Fig 5.1 – Sensor inside Girder

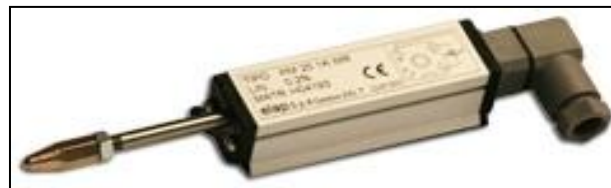
Fig 5.2 – Linear Potentiometer

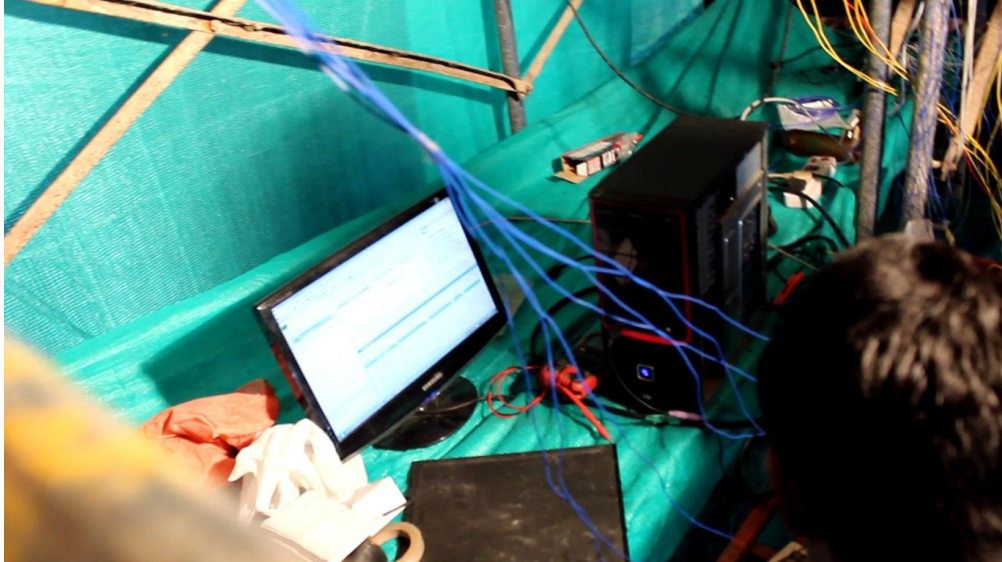
- Deflection and strain sensors were mounted and all of them were connected by wire assembly which were brought at a single point where National instruments equipments were placed. The wires were plugged in the NI DAQ to acquire the desired reading of deflection and strain at various points.

Fig : NI DAQ
