CASE STUDY OF RALTAM BRIDGE

R & M international was awarded the contract to carry out instrumentation of Bridge No.132 and Bridge No. 114 of Godhara-Ratlam section of Ratlam Division of Western Railway.

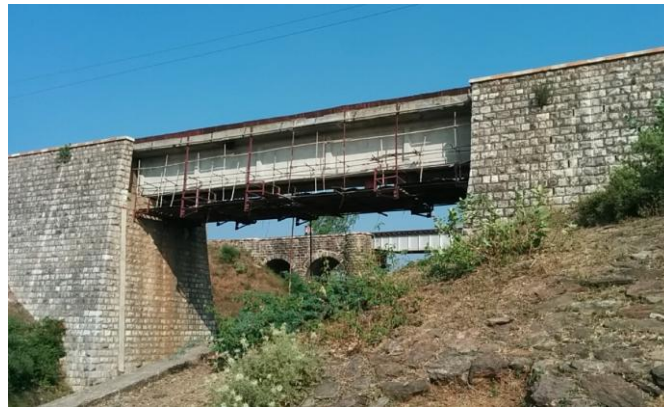
Bridge no. 114UP of Godhara-Ratlam section of Ratlam Division Of Western Railway located near Dahod have Four spans of 18.3m PSC I Girders.

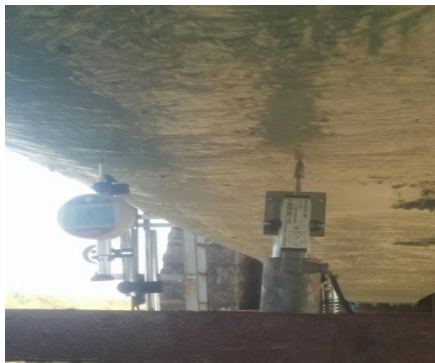
Fig. Linear Potentiometer

1) **Deflection Test-** To assess the deflection on the girder before and after strengthening the test was carried out using Linear Potentiometer .The deflection was measured at the mid span of the girder. An independent support system using steel cribs was erected to enable recording of the deflection data for the girder with precision.

- On Bridge No.114 & Bridge no.132 Deflection & Natural Frequency tests were performed before strengthening and after strengthening by placing linear potentiometer & accelerometer under the girders which was connected to National instrument DAQ which was connected to Laptop to obtain the Graph at static load and at dynamic loads. WAG – 7 Engine was used as the load to calculate the deflection and natural Frequencies.
- The data collection and analysis is done with the help of DGC cDAQ 9178 software for deflection. The electric signals through the cable goes to the NI 9205 module which is attached to NI compact DAQ 9178 chassis & this hardware is integrated to the cDAQ 9178 software.

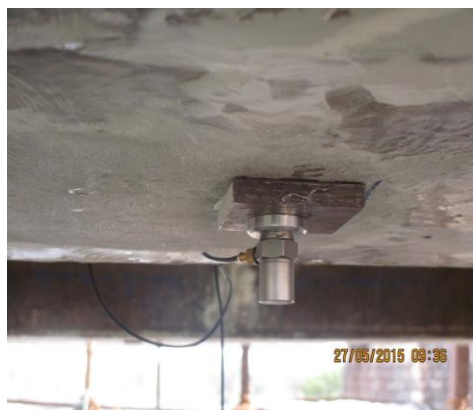
Fig – Accelerometer

2) **Vibration /Natural Frequency Test-** To assess the Natural frequency of the girder before and after strengthening accelerometer were used. The accelerometer was placed at the mid span of the girder. The accelerometer was fixed to the bottom chord of the girder.
