STRUCTURAL HEALTH MONIROING OF VISAKHAPATNAM PORT TRUST BRIDGE

OVERVIEW

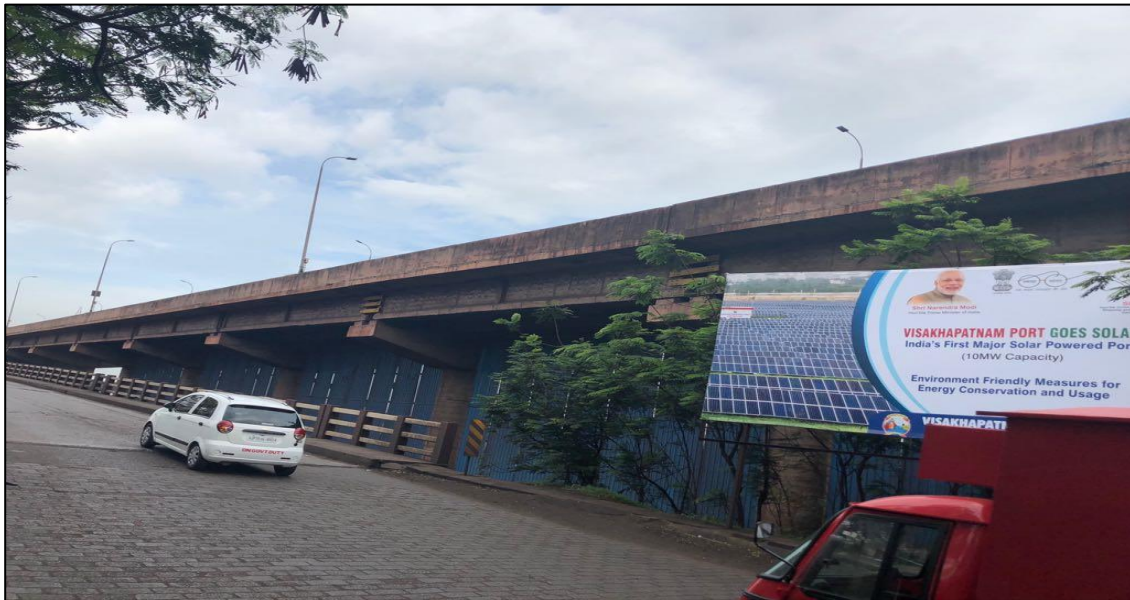
Fig 1:- Visakhapatnam port trust Bridge .

This Flyover in located in Vishakhapatnam connects the port area and Airport to Vishakhapatnam city and NH-5. The length of this flyover is approximately 1.2 km. This flyover bridge is constructed on pile foundation, having Reinforced concrete piers. There was little deterioration observed in structural members and bearings. All spans are deviated longitudinally from their original positions and different gaps were found between them.

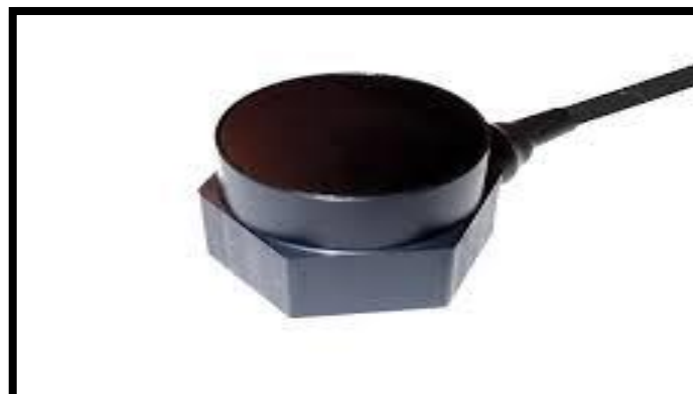
Fig 3 :- Accelerometer placed under the Girder

- **Natural Frequency measurement:** - Natural frequencies of the RCC girders and deck were measured by installing accelerometer on the deck. All the 5 spans were tested for their Natural Frequency in Dynamic Motion .

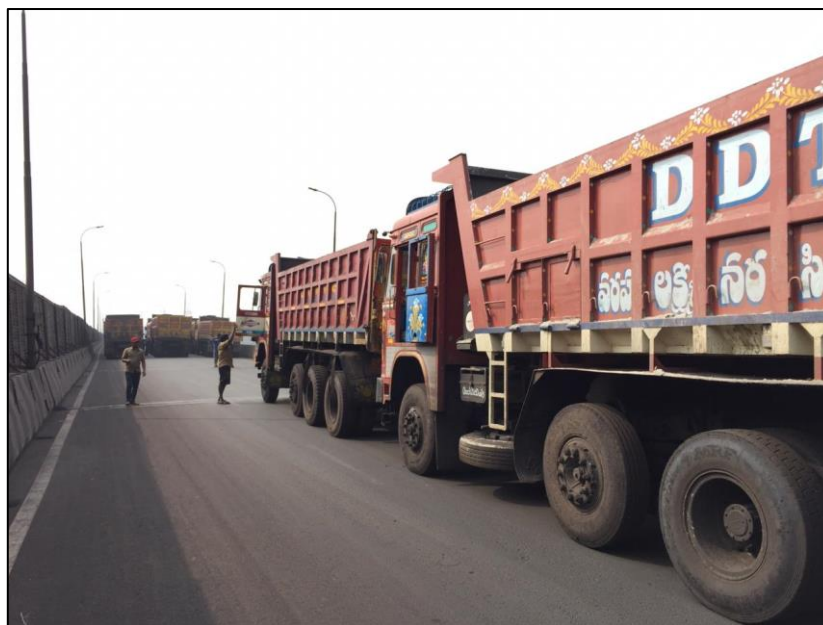
Fig 7 :- Trucks placed for Load testing

Static load testing and Dynamic load testing were performed to know the behaviour of girders in flexure under live loads. Six loaded trucks of 22 tonnes each were used to perform the load test. Axle load distribution and load configuration of loaded test trucks were used for static loading. They were placed behind each other in three lanes at the centre of the deck for each span.

- 4) The maximum deflection of 6 mm has been recorded at mid-span of the girder at the centre of span 69-70 where Linear Potentiometers were placed
- 5) The natural frequencies of the girders are in the range of 4.411 Hz to 4.612 Hz. There is very minor variation in natural frequencies which indicate that the flexural stiffness of girders is almost similar.
